EVALUATION OF MEMBRANE-TYPE MATERIALS FOR STREAMBANK EROSION PROTECTION

Dewey W. White, Jr.

Geotechnical Laboratory
U. S. Army Engineer Waterways Experiment Station
P. O. Box 631, Vicksburg, Miss. 39180

August 1981

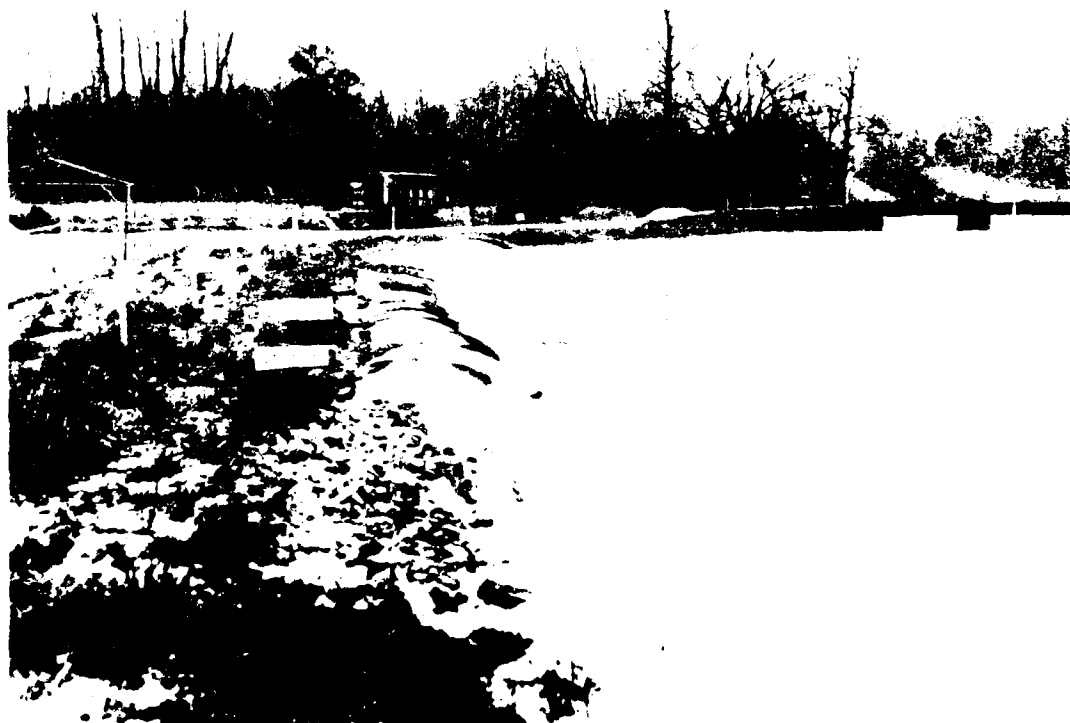
Photo 37. Typical view of deteriorated sandbags

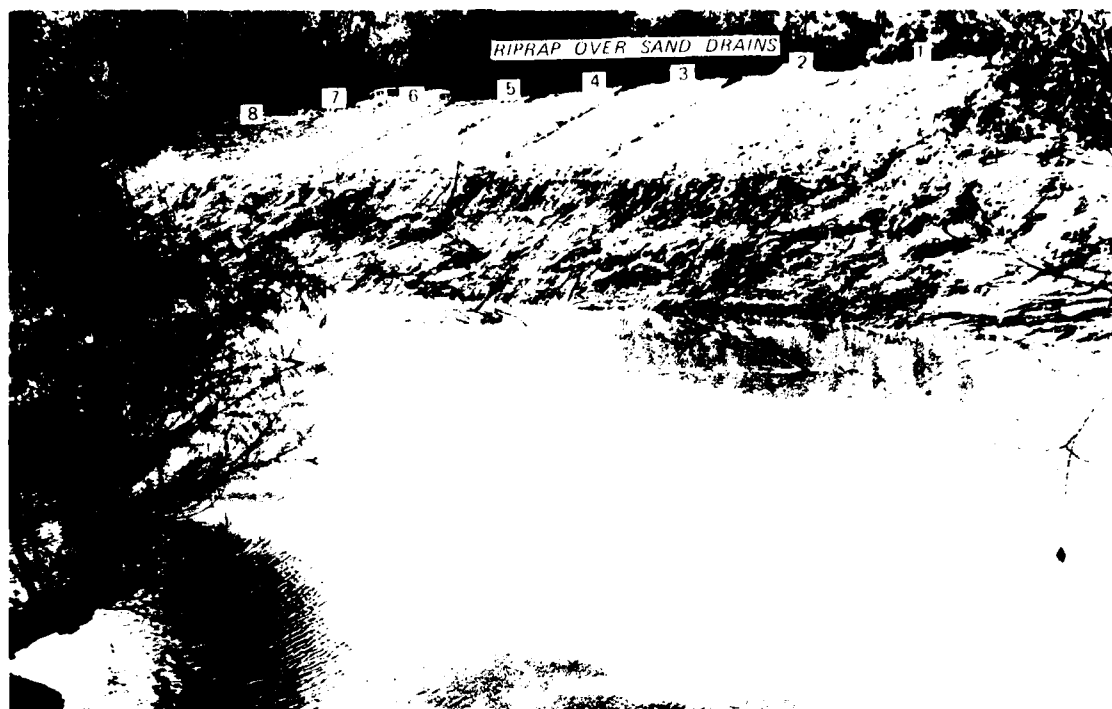
Photo 38. View (looking upstream) of test area during high water level in creek (note membrane raised on Items 5 and 6 due to air entrapped beneath the membrane)

eliminated by stretching the membrane taut on each step and placing ballast of sacked concrete at the face of each step to prevent ballooning of the membrane. The second problem was also solved by using sacked concrete mix in anchor ditches and in other areas where ballast was required. The original sandbags used at Durden Creek were replaced during October 1980 with bagged concrete mix, and ballast consisting of sacked concrete mix was placed at the face of each step of the stepped MESL item (Item 1). The air observed to be entrapped beneath the membranes (Items 5 and 6, Photo 38) during high-water levels in the creek did not cause any noticeable effects on these materials. In fact, this condition helped to raise the height of the top bank and prevented flood waters of the creek from overtopping the bank in this area. As the high water receded, the membrane returned to its original position on the slope of the bank. The bank in the test area of Durden Creek remained stable as a result of the protection provided by test materials.

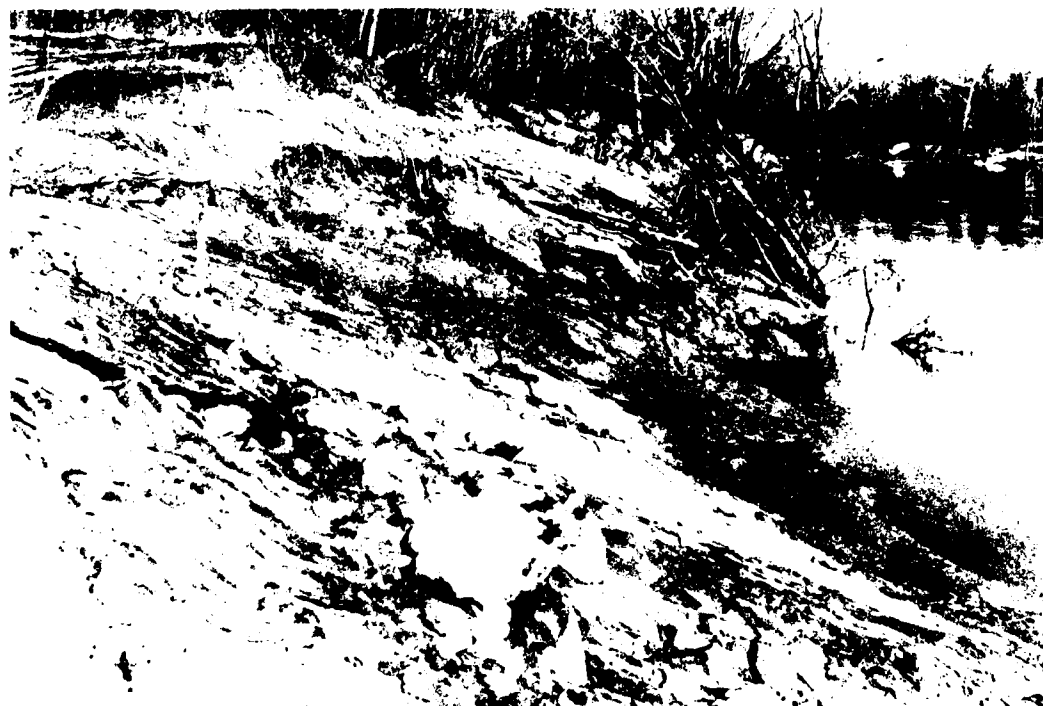
Photo 67. View (looking upriver) of test bank where shifting and sliding had occurred at the toe anchor ditch after a sudden drop in the water level of the river

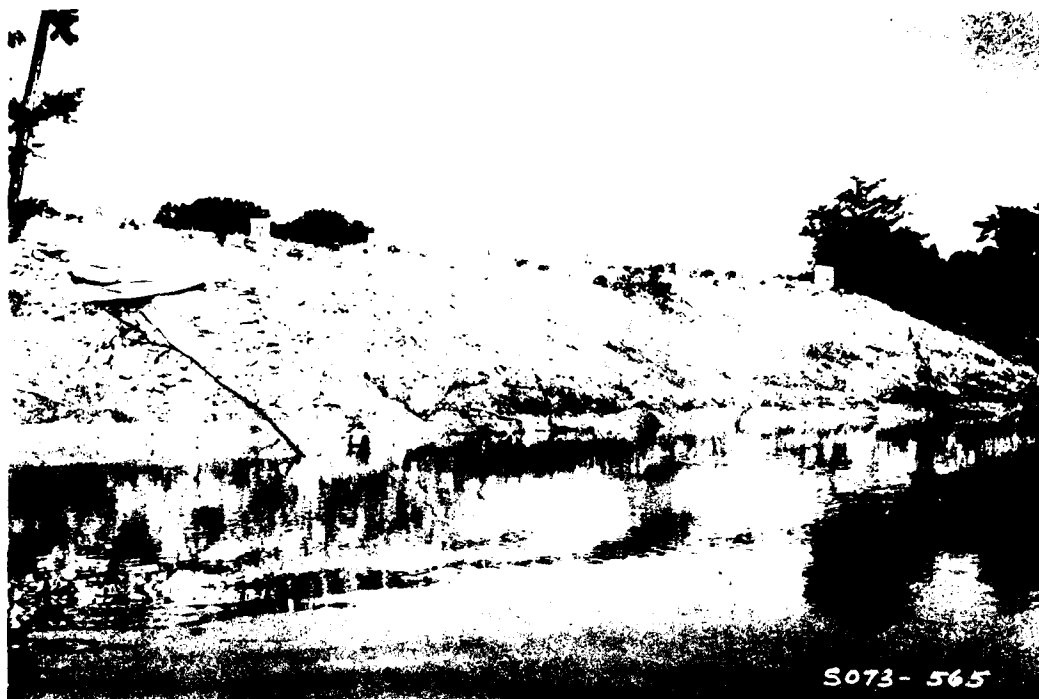
(60-hr period). Photo 73 presents the condition of the test area on 12 May. The test materials on all items were damaged and torn (Photos 74-76) because of bank failure. Since March, the bank behind the test materials had been saturated with water, and then the sudden drawdown caused the bank to fail, resulting in the failure of the test materials. The riprap on Item 7 (standard for comparison) also settled and shifted. Sliding and shifting of the bank also occurred upstream (Photo 77) and downstream (Photo 78) of the test area.

Photo 78. View (looking downriver) of bank adjacent to the downriver edge of the test area which had failed due to the rapid drop in water level, 12 May 1980
